THAMES RIVER BASIN
WINDHAM, CONNECTICUT

POTASH POND DAM
CT. 00193

PHASE I INSPECTION REPORT
NATIONAL DAM INSPECTION PROGRAM

JANUARY, 1981

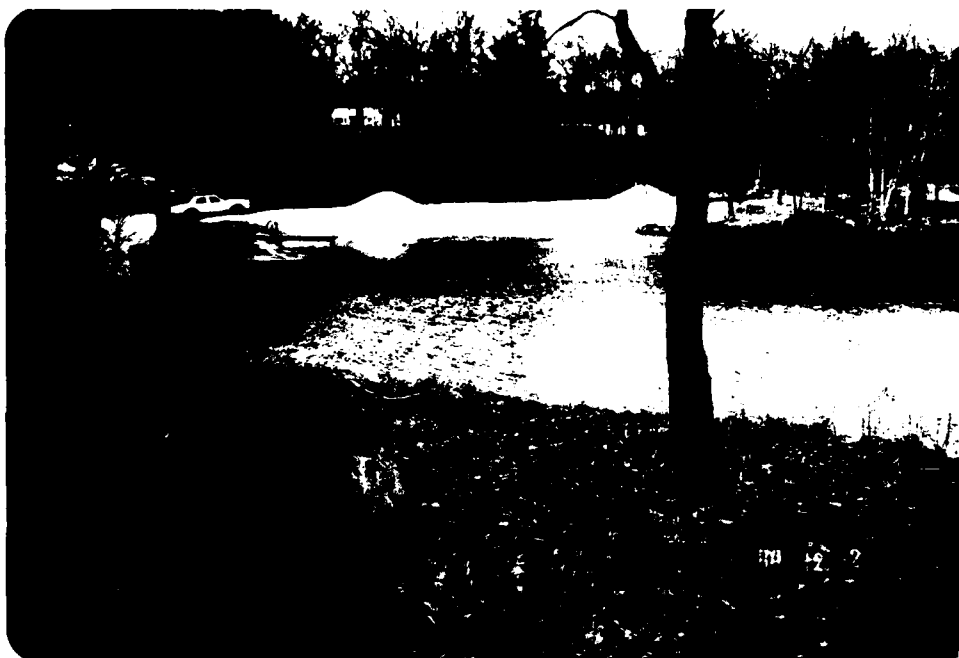
PHOTO C-1: Crest of dam and left abutment.

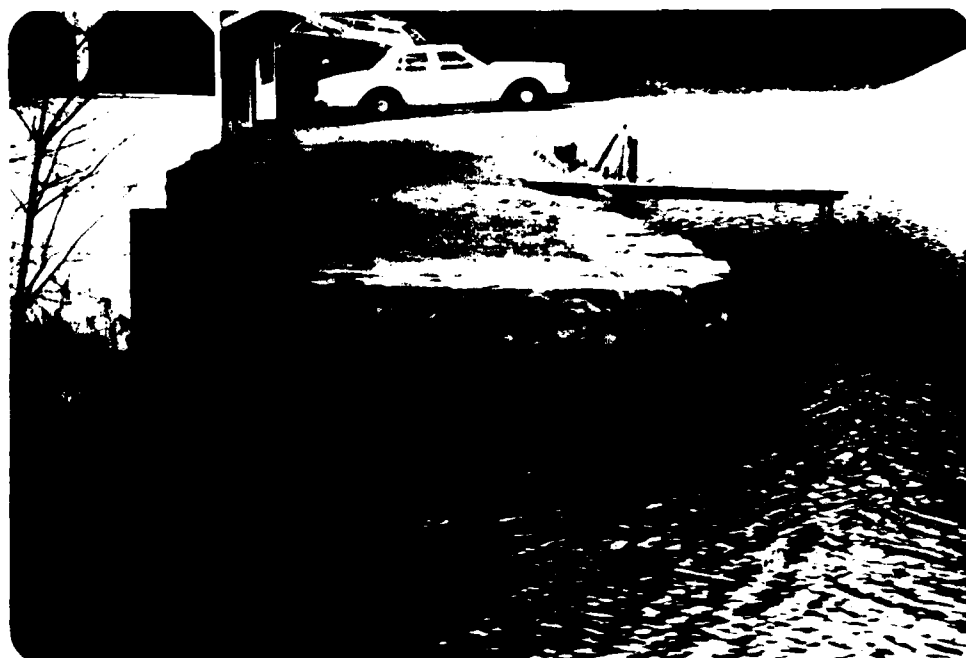
PHOTO C-2: Crest of dam and right abutment.

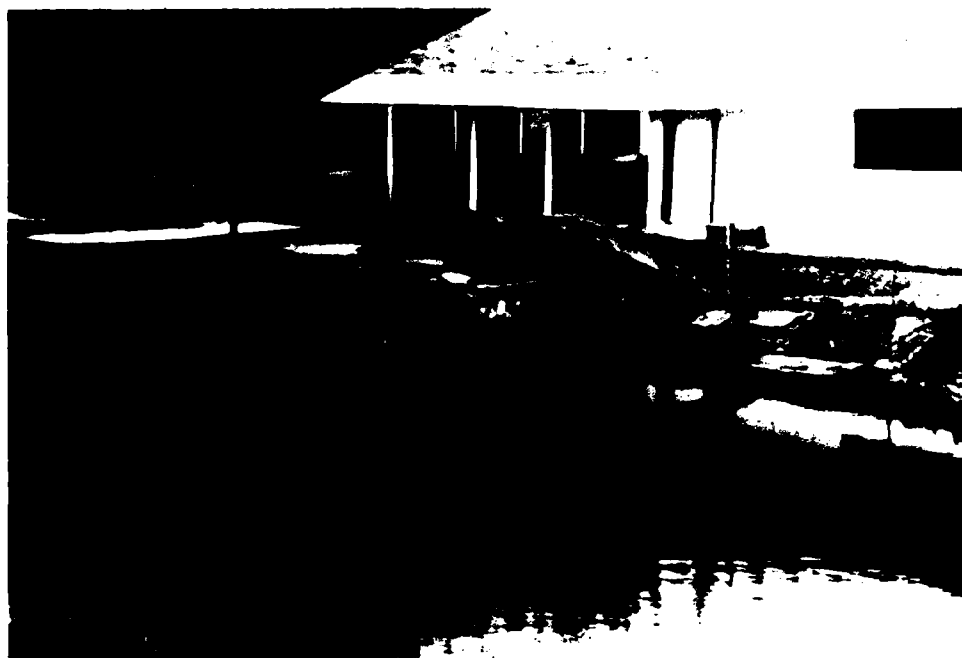
PHOTO C-13: Sloughing and erosion of the stone masonry of right portion of the upstream face of the dam.

- g. Investigate and recommend methods to repair the stone masonry and halt erosion along the upstream face of the dam.
